Manhole Inspection Summary

Manhole # S33EE_047MH

Insp Date: **2/22/07 10:18 AM**

Location Address: **1212 CATHEDRAL ST**

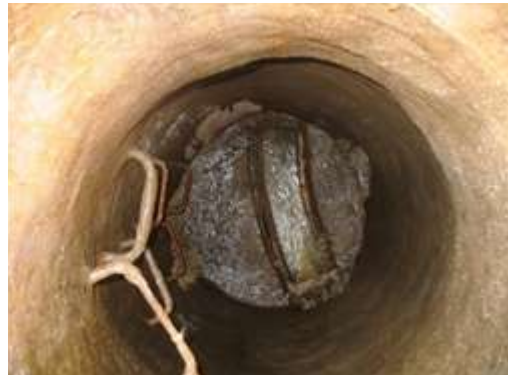
Top View

Bench debris. Corroded steps.

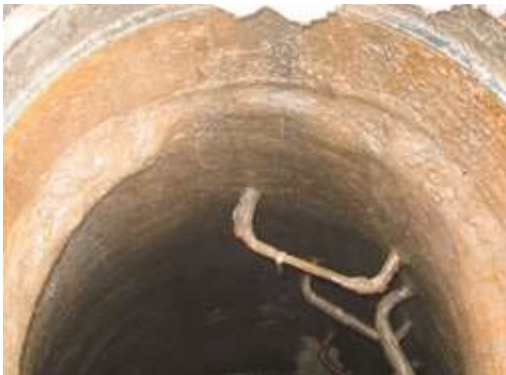
Defect

Frame leaks. Adjustment infiltration.

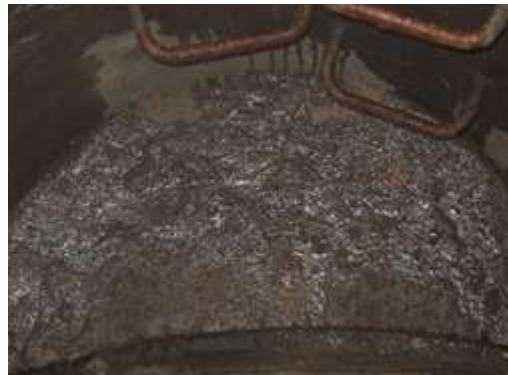
Defect

Bench debris - Bench infiltration.
